Thanks Dave. I have found this on internet for Audi Delta CC.

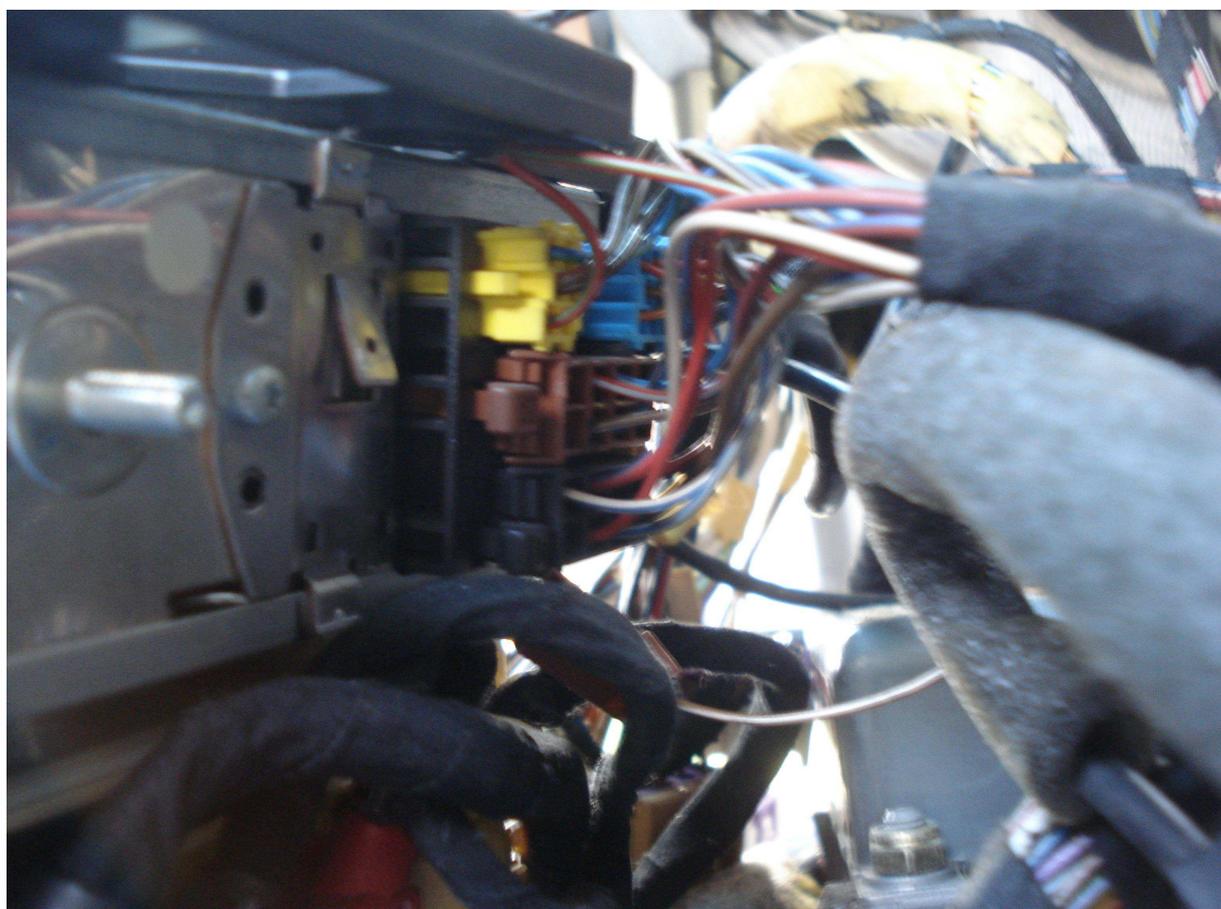
And found one picture in my pc. My radio wiring.

It seems that the wires from the radio went into the amplifier located in the speaker. What to do now when we have a common ground last speakers? This seems complicated 😊

1-2-4-5-3
