## Removing and installing ESP sensor unit - G419-

The ESP sensor unit -G419- is located at the front of the centre tunnel below the air conditioner.

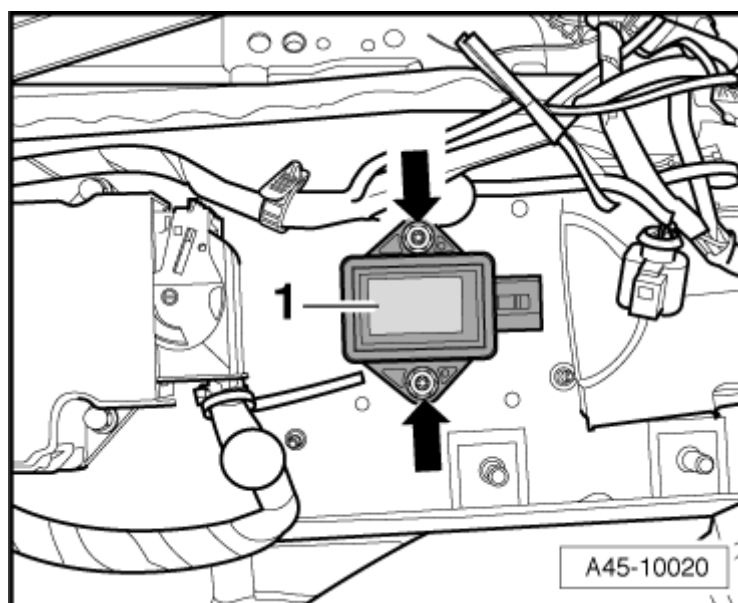
- Installation is carried out in the reverse sequence.

When installing the ESP sensor unit -G419-, make sure it is correctly seated in its bracket and is free of stress.

**Do NOT use the securing bolts to forcibly position the ESP sensor unit -G419-.**

- Tighten securing bolts to 10 Nm.
- When renewing the control unit, select the "Replace" function for the relevant control unit in the "Guided Fault Finding".
